# YOUR Inspection Report

64 Mordecai Lincoln Road - The Residency and Mill  
Scituate, MA 02066

RE: Report No. 2044  
64 Mordecai Lincoln Road - The Residency and Mill  
Scituate, MA  
02066

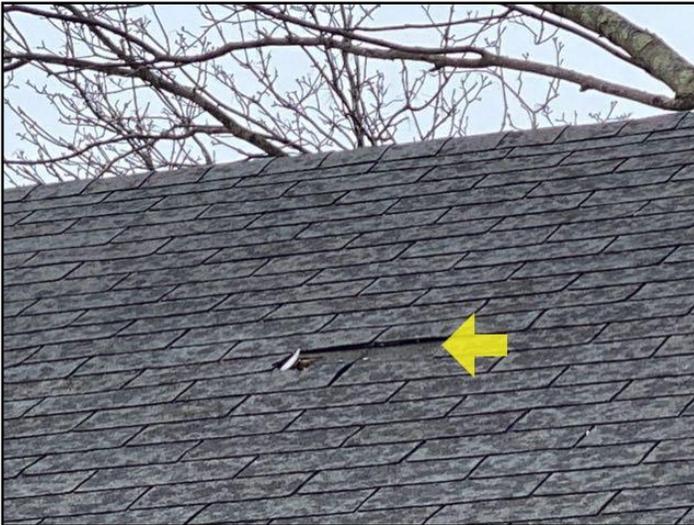
The asphalt roof covering on the mill structure is well into its useful life and nearing full depreciation. There is an open void on the front gable roof line that is actively allowing water to gain entry to the structure. This needs to be repaired immediately. Others areas of the roof sheathing, from interior examination, appear to be in decent condition. The condition of the shingle roof covering itself is heavily worn. These are non-architectural grade shingles that are most likely past their anticipated lifespan. Complete roof covering replacement would be highly recommended in the near future to properly protect the structure.

*Detail of damage to mill roof covering*

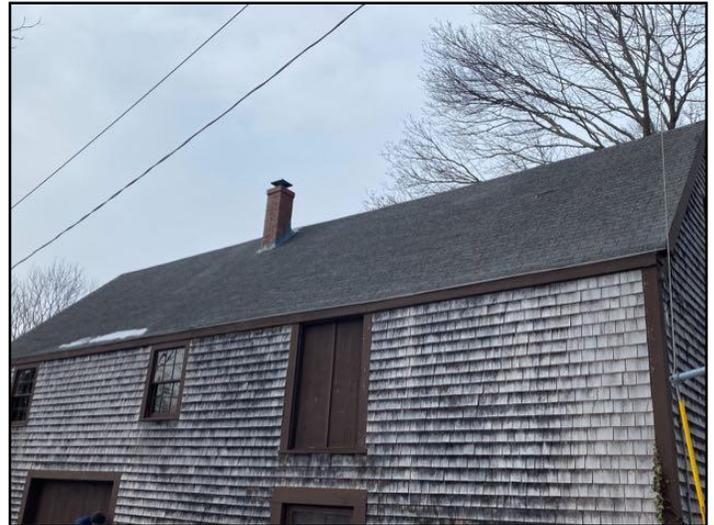
*Overview of mill roof covering*

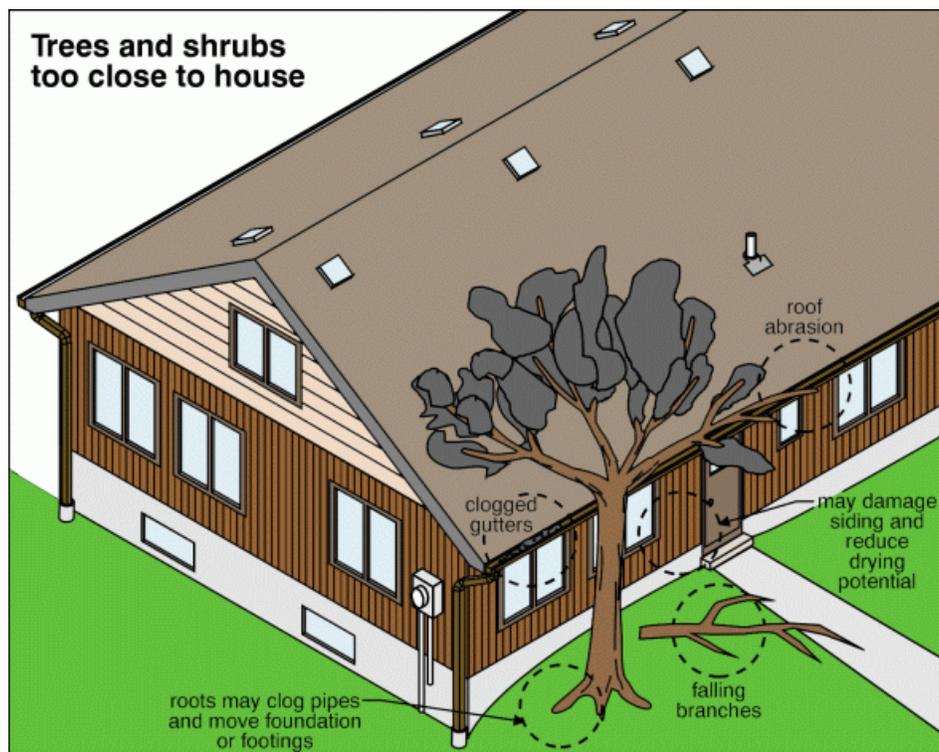
**Condition:** • Trees or shrubs too close to building

There are numerous trees that are growing nearly in contact with the residence structure. This is generally not recommended for a variety of reasons: (1) vegetation near exterior siding tends to trap moisture against the siding, increasing the potential for decay in building fabric; (2) vegetation in contact with a structure increases the likelihood of insects transferring into the structure and; (3) the roots of trees have been noted to disrupt nearby foundation materials over time. Removal of mature trees within six feet of any structure should be strongly considered. Discuss with arborist.

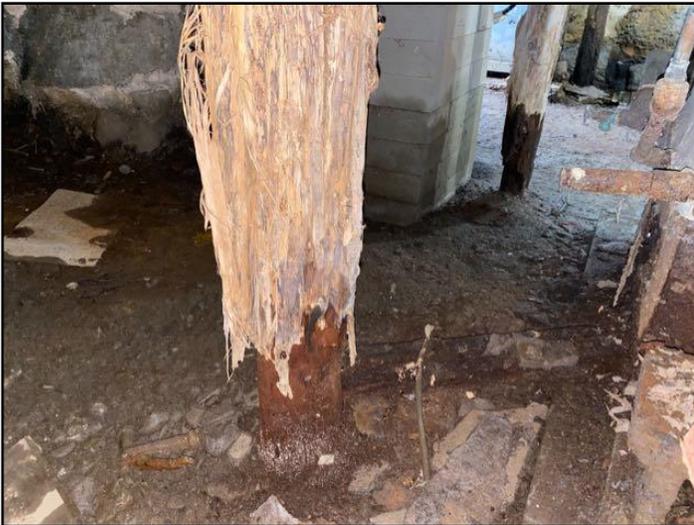
There are several older, cedar support posts in the basement of the residence. These feature have sustained significant damage from exposure to water. They should be the subject of through evaluation by a qualified contractor.

Heavy decay to cedar posts

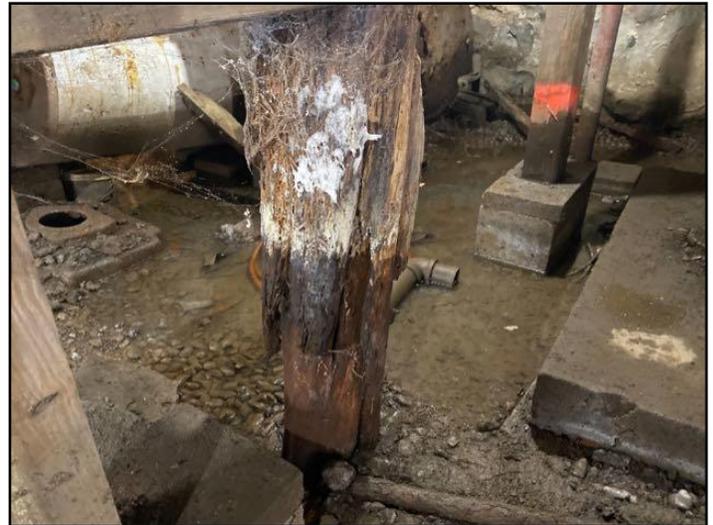
Heavy decay to cedar posts

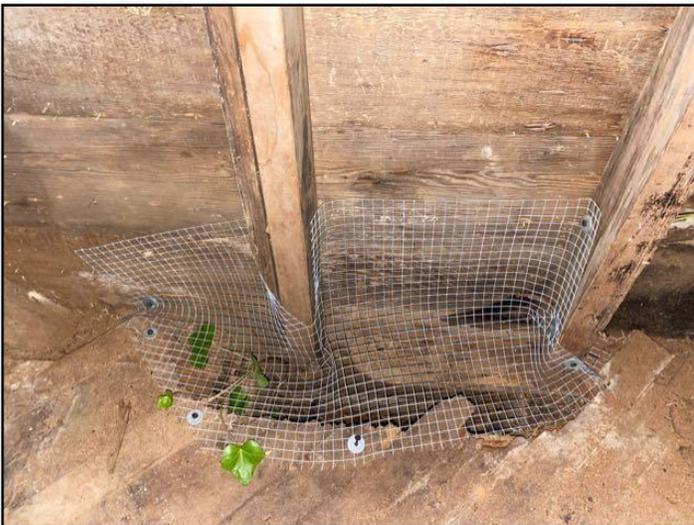
Water has been gaining access to the rear interior of the mill for some time. Relatively significant amounts of water damage and decay were noted along this elevation from the roof line down to the first floor. Moisture readings were taken from a variety of areas along the interior of this elevation and all were high, increasing the lower you went on the elevation, (which is not surprising). While this report is not diagnostic in nature, it appears the roof flashing along the length of this elevation failed years ago and has ever since been allowing water to run inside the wall along framing and sheathing. Compounding this condition, prevailing winds along this rear elevation work to blow any roof drainage back against the siding. Further evaluation is promptly need to arrest any further water infiltration. While it is currently unlikely that framing members have suffered terminal amounts of damage, a general contractor or qualified specialist should be brought in to properly document and evaluate the framing. If left unaddressed, damage will most likely become more structurally compromising.

Heavy damage to flooring

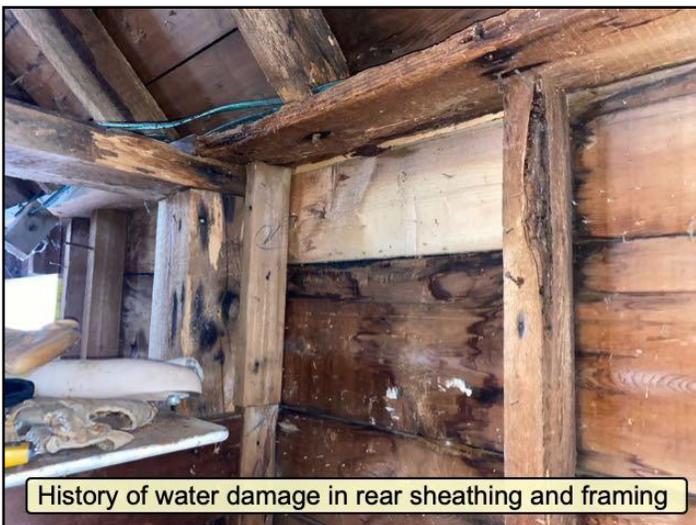
History of water damage in rear sheathing and framing

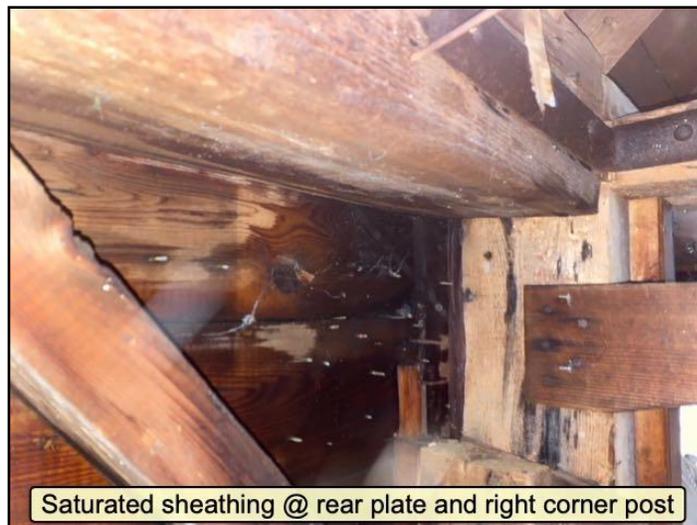
Saturated sheathing @ rear plate and right corner post

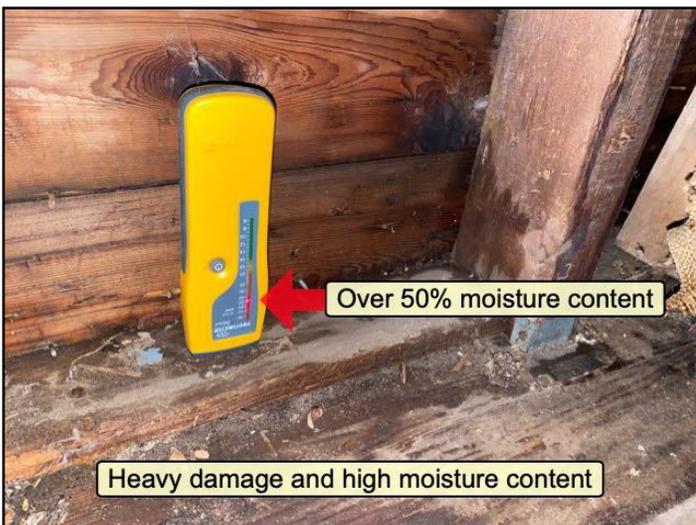
Over 50% moisture content

Heavy damage and high moisture content

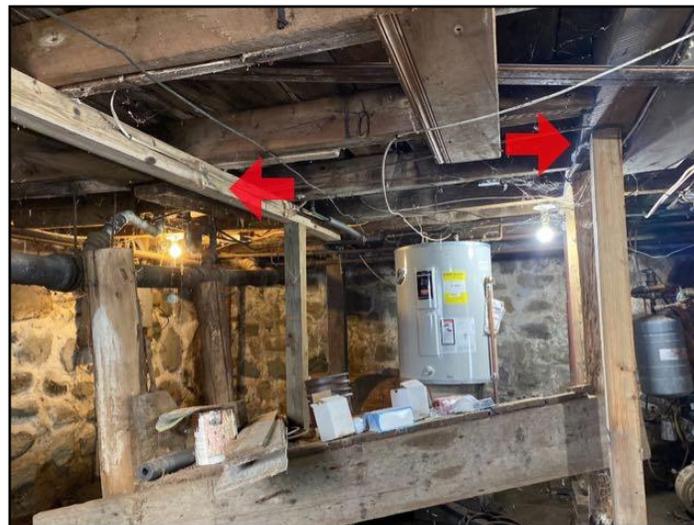
Additional post and beam supports have been installed, running front-to-back, in the basement of the residence structure. These two features are not properly secured in place. At least one post is loose to the touch and none are properly secured where they come in contact with the beam they support. This installation should be further evaluated by a qualified contractor.

*Improvements recommended*

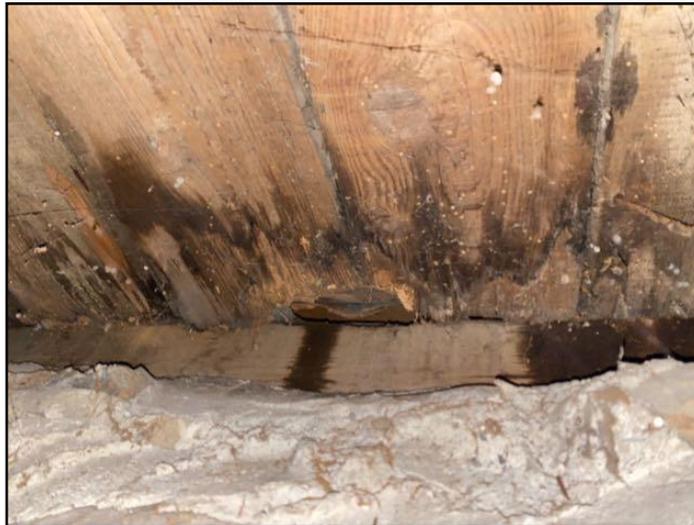
Damage and decay were noted to subfloor at the front of the basement, beneath the front entry vestibule of the residence structure. The scope of this water damage could not be determined and \*may\* include the sill in and around this area. Further evaluation by a qualified contractor will be needed.

*Water damage to sub flooring in residence*

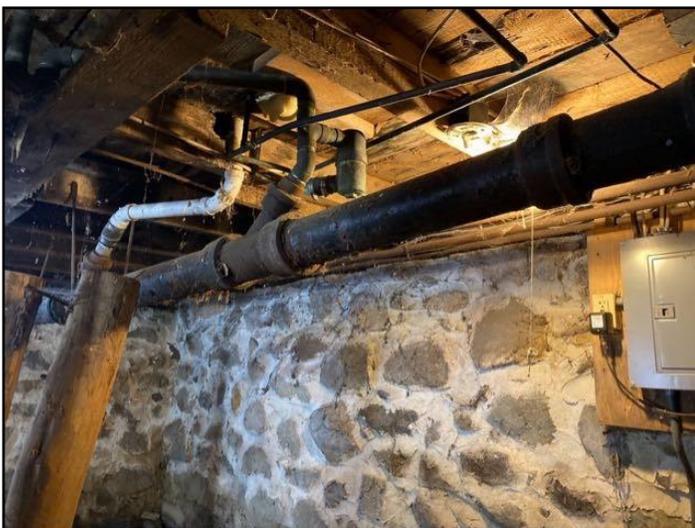
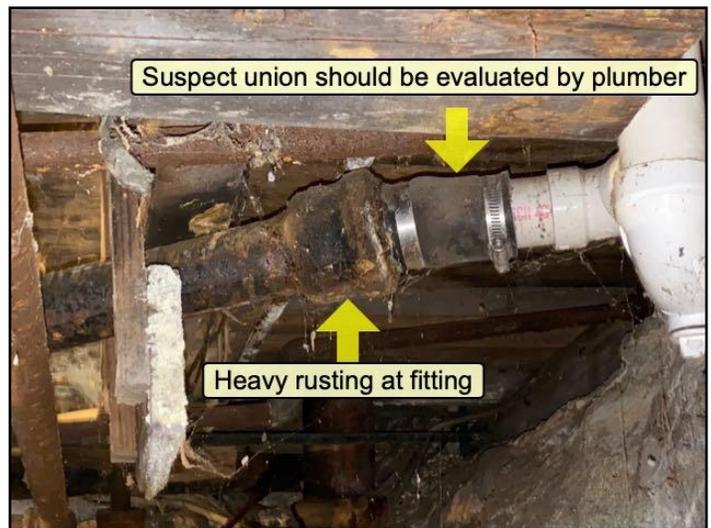
There is a fairly significant amount of older, cast iron drain line in the basement. These lines are most likely original to the house, making them nearly 100 years old. Cast iron oftentimes will rust from the inside out and generally have an anticipated life span of 50-70 years. While the overall condition of these lines is currently fair, areas of scabbing and rusting were noted - especially at pipe unions on horizontal runs. While not an immediate concern the cast iron drain lines in the home will need to be replaced in the near future. Recommend you consider and consult with a licensed plumber.

Aged and rusting cast iron drain lines

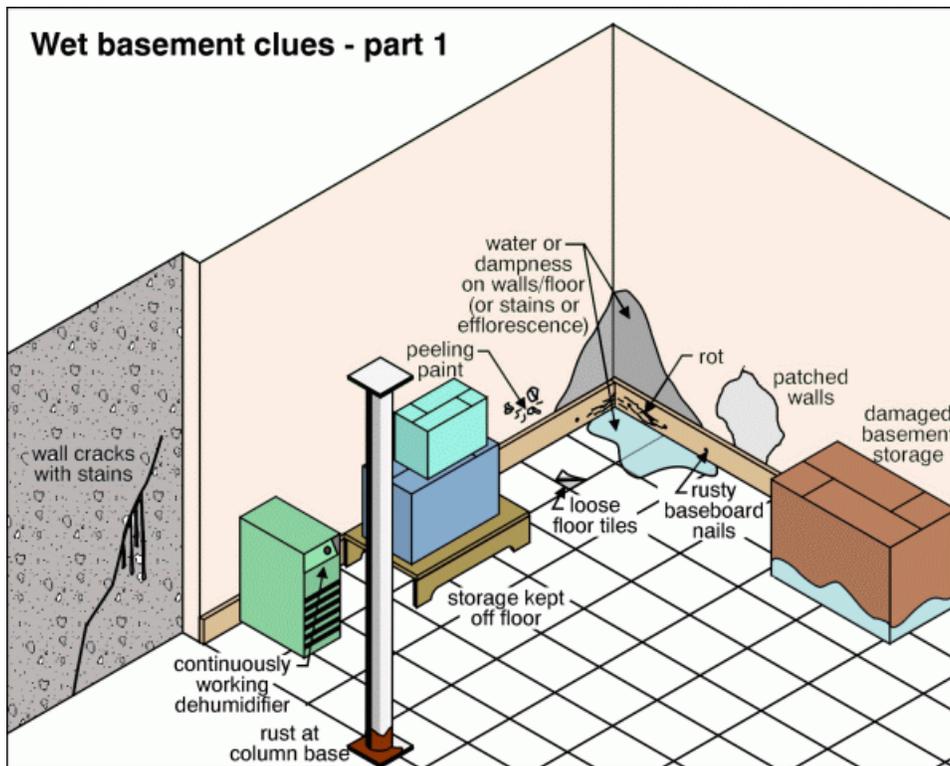
At the time of this site visit there was at least three to four inches of standing water covering at least 50-75% of the basement floor. Given the condition of piping, framing and other mechanical components in the basement, this has been a chronic condition negatively impacting the building -perhaps for decades. Comprehensively, this is the most important - and challenging - issue regarding the long term interest and preservation of the structure. Moisture readings taken from many of the building's floor framing in the basement were high, (from 25-90%). This condition contributes to rusting on metal drains and structural supports, decay in wood framing members and the increased likelihood of mold and/or mildew growth. As noted elsewhere in this document, some structural components have been heavily impacted by this wet condition. Consultation with qualified contractors will be needed to devise a comprehensive list of strategies and solutions to correct this environment.

## Wet basement clues - part 1

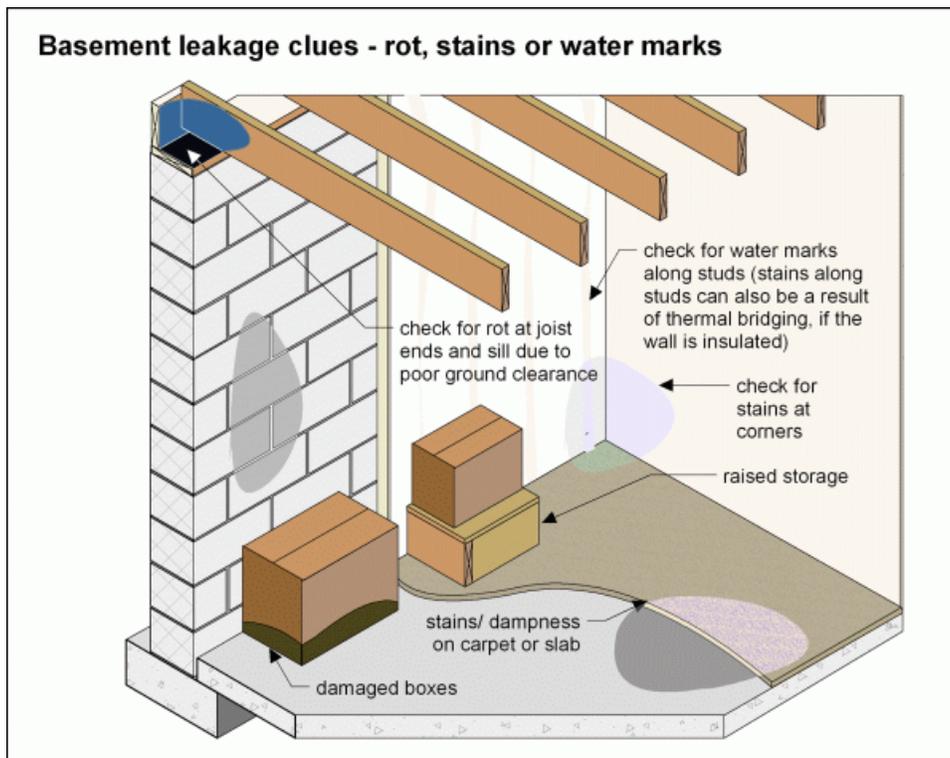
## Basement leakage clues - rot, stains or water marks

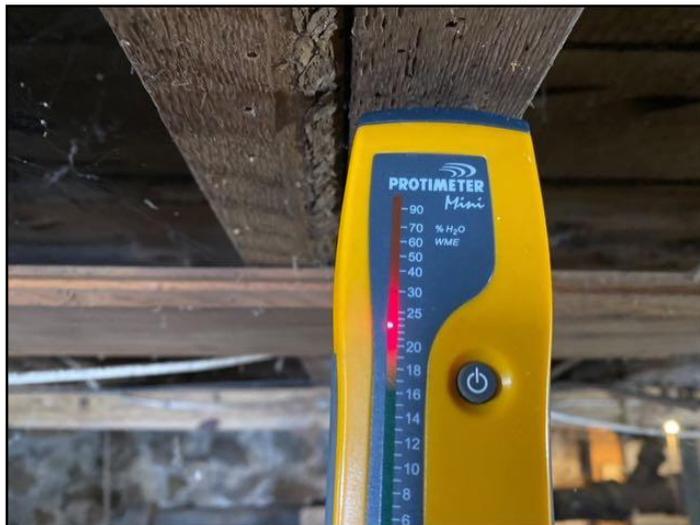
*High moisture readings throughout framing*

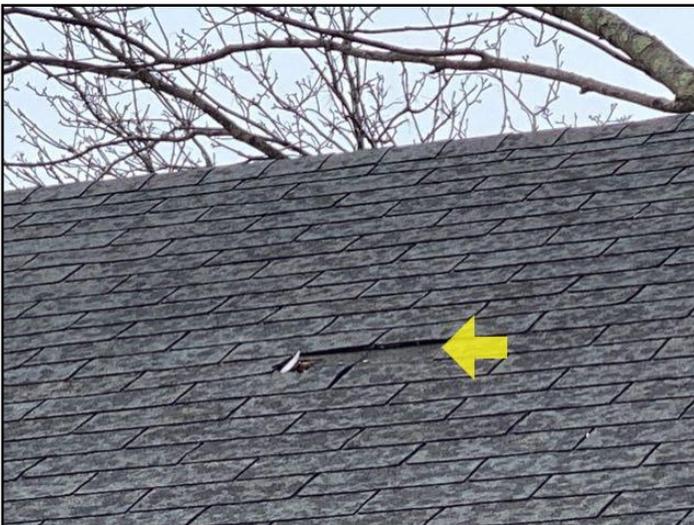
The asphalt roof covering on the mill structure is well into its useful life and nearing full depreciation. There is an open void on the front gable roof line that is actively allowing water to gain entry to the structure. This needs to be repaired immediately. Others areas of the roof sheathing, from interior examination, appear to be in decent condition. The condition of the shingle roof covering itself is heavily worn. These are non-architectural grade shingles that are most likely past their anticipated lifespan. Complete roof covering replacement would be highly recommended in the near future to properly protect the structure.

*Detail of damage to mill roof covering*

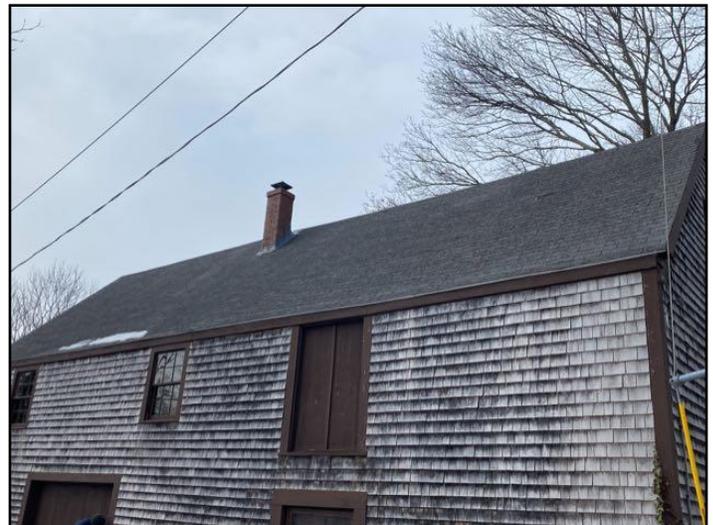
*Overview of mill roof covering*

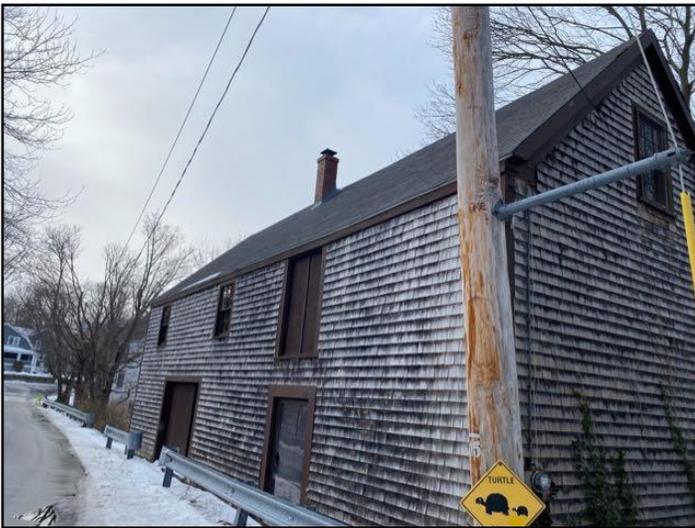
Gutters and downspouts needed

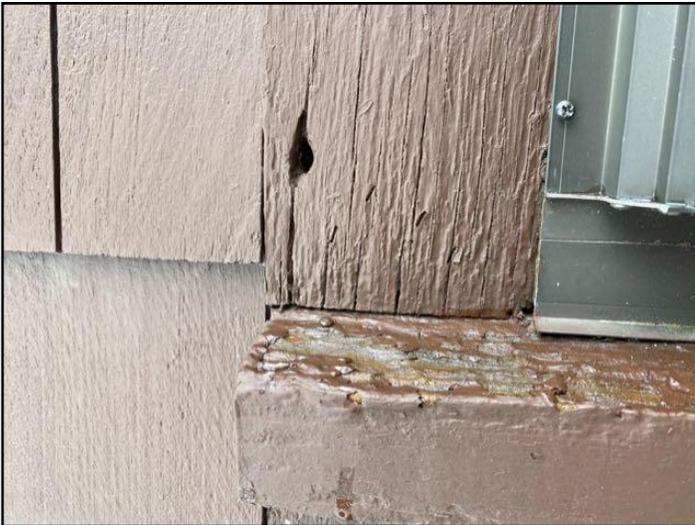
There are numerous examples of wood decay in exterior window trim and sills on all elevations of the residence structure. These areas should be properly repaired by a qualified contractor.

*Decay in trim*

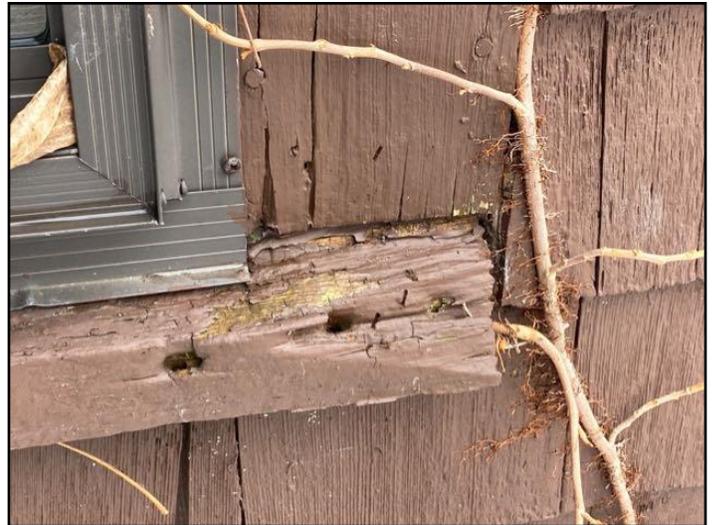
*Decay in trim and sill*

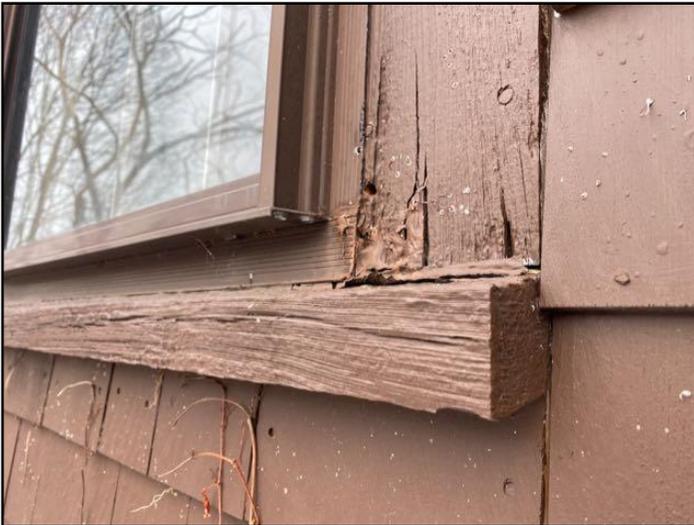
*Decay in trim*

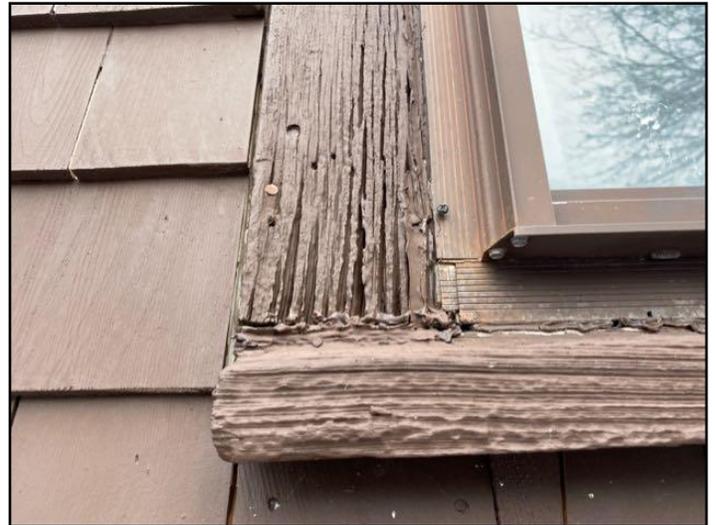
*Decay in trim and sill*

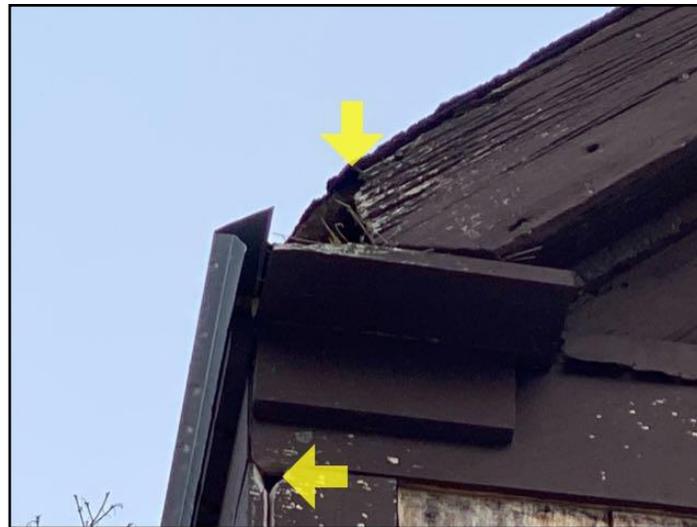
There is visual evidence of wood decay and pest entry points to the gable return on the left side of the mill structure. These areas should be properly repaired by a qualified contractor and the mill should be examined and treated annually by a licensed pest control company.

*Decay and pest entry*

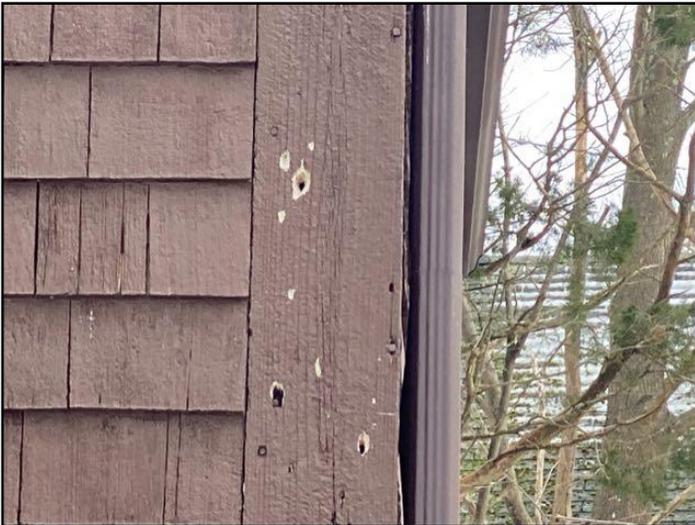
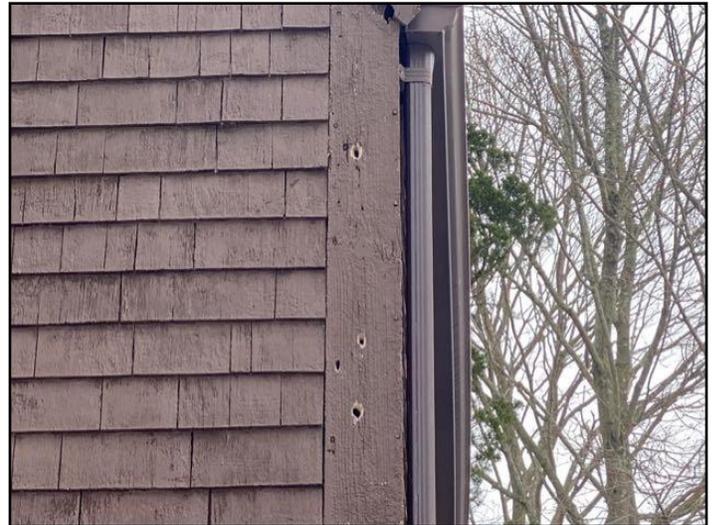
There is apparent bird or carpenter bee damaged to the rear, right corner board on the residence structure. This needs to be properly repaired by a qualified contractor.

*Bird or insect damage to wood trim*

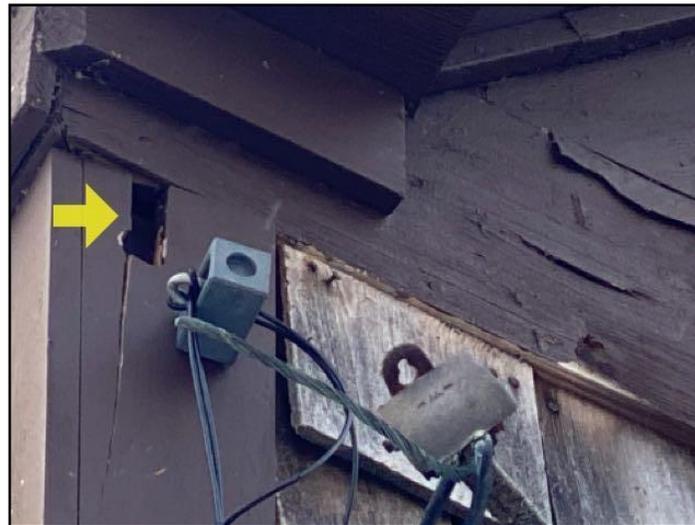
There is an open void at the top of the front, right corner board of the mill structure. This seems like a potential entry point for insects, rodents or bird to enter the structure. Evaluate further and repair as needed.

*Damaged*

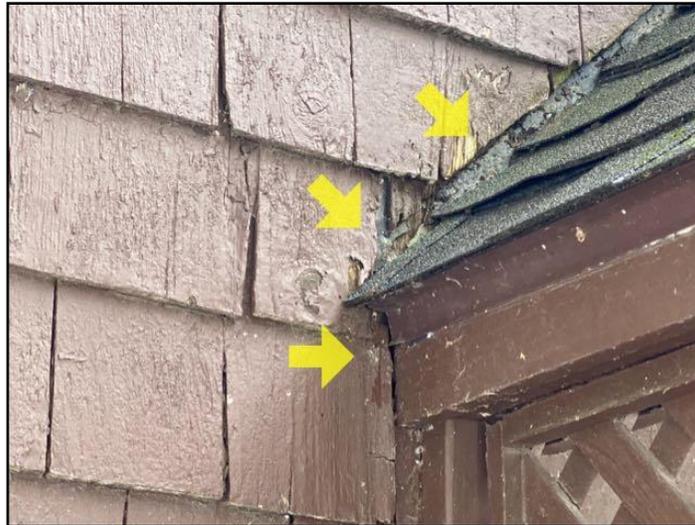
*Left side of front vestibule*

While heavily repainted, the shingles at the left side roof line of the front vestibule on the residence suggest wood decay. This should be further evaluated. Any repairs here should also include close examination and repairs to the flashing for this feature.

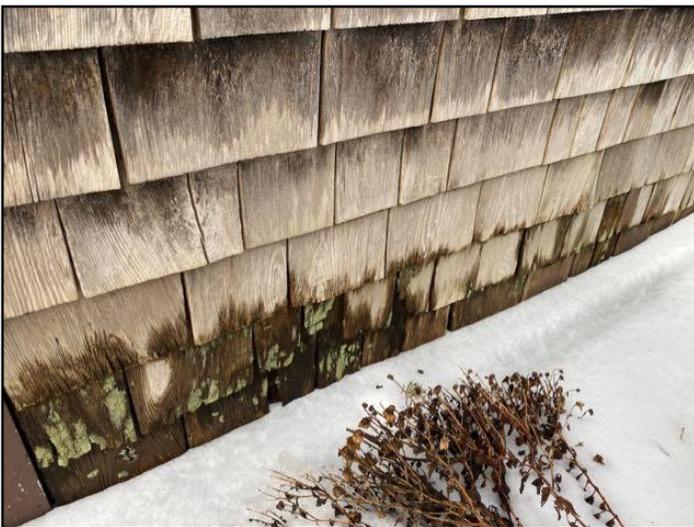
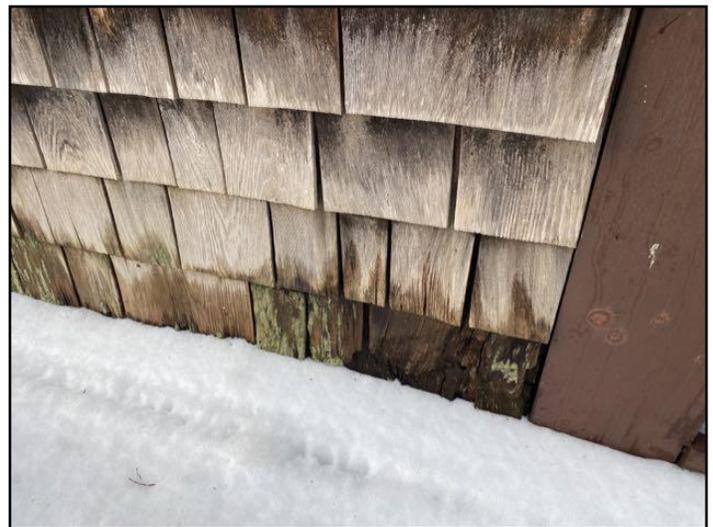
As discussed earlier in this document, unmanaged roof drainage around the Mill structure is having a negative impact on wood shingle siding. On the front elevation lower courses are exposed to near-constant moisture, drastically increasing the rate of decay. (Make note also, the sills along the front elevation are nearly below grade.). On the rear elevation roof drainage is constantly blown back against the siding, exposing the wood shingle siding to an unnecessary level of water. Repairs to any damaged wood siding or framing will be needed in these areas on the mill.

*Decay in lower courses of siding*

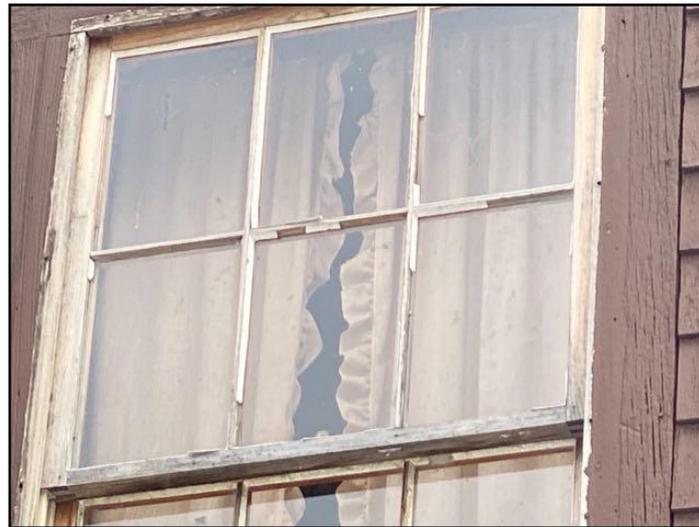
Many of the wooden sash windows on the residence display broad areas of failing window glazing. Repairs will be needed.

Example of failing window glazing on sash

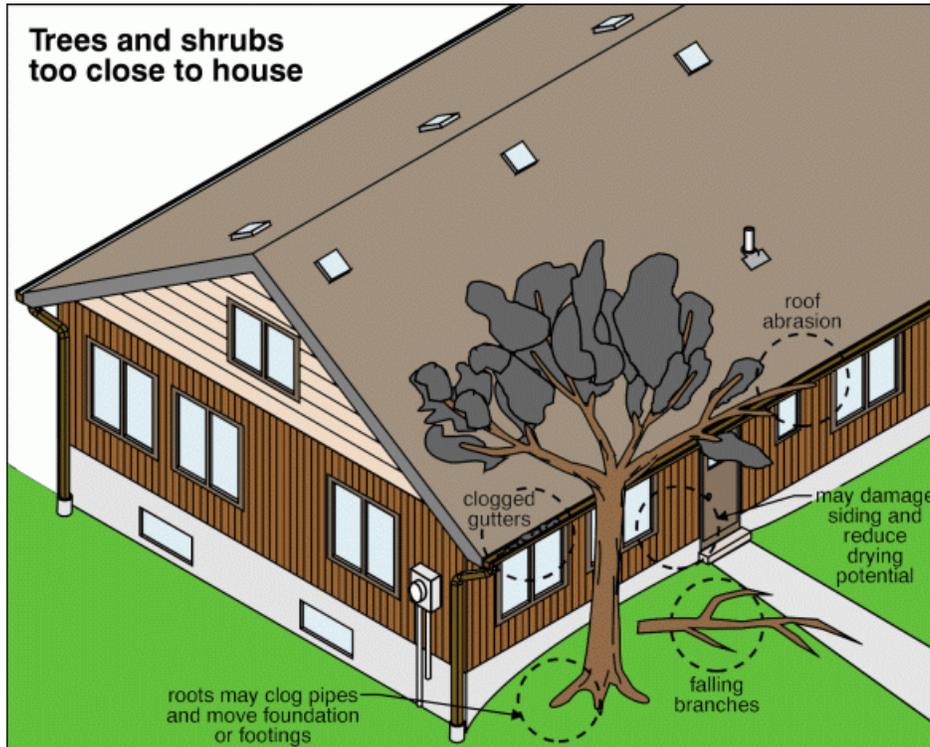
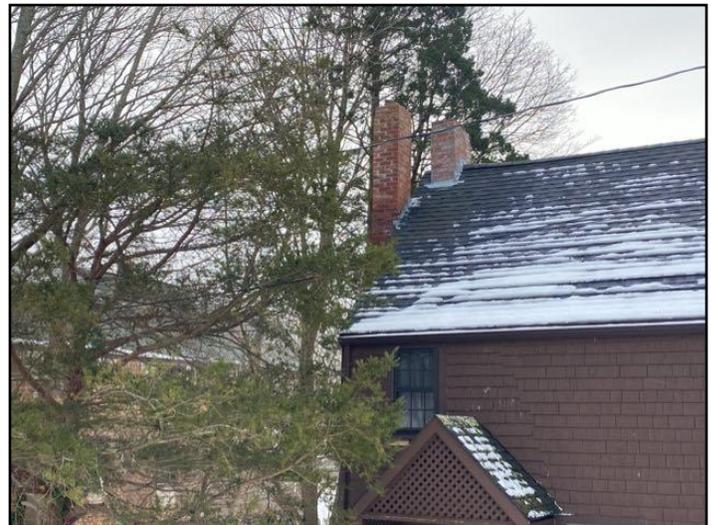
There are numerous trees that are growing nearly in contact with the residence structure. This is generally not recommended for a variety of reasons: (1) vegetation near exterior siding tends to trap moisture against the siding, increasing the potential for decay in building fabric; (2) vegetation in contact with a structure increases the likelihood of insects transferring into the structure and; (3) the roots of trees have been noted to disrupt nearby foundation materials over time. Removal of mature trees within six feet of any structure should be strongly considered. Discuss with arborist.

Trees too close to structure

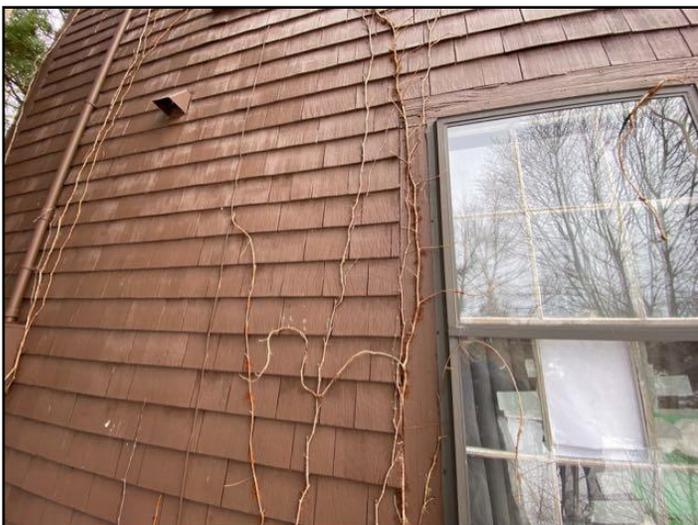
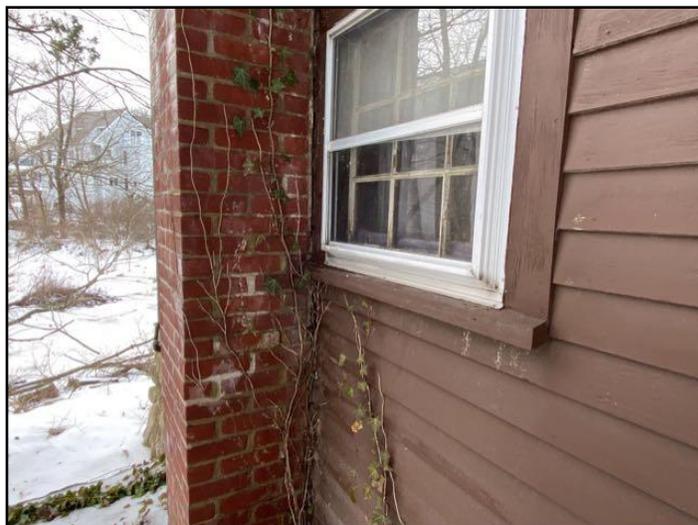
There are numerous example of vine growth on the exterior siding of the residence structure. It is generally not advised to allow vegetation grown on dwellings as this can (1) increase the likelihood of insects transferring into the structure; (2) trap moisture against the siding and; (3) cause damage to the siding. Vegetation should be kept at least one foot away from all exterior elevations.

*Vines on residence structure*

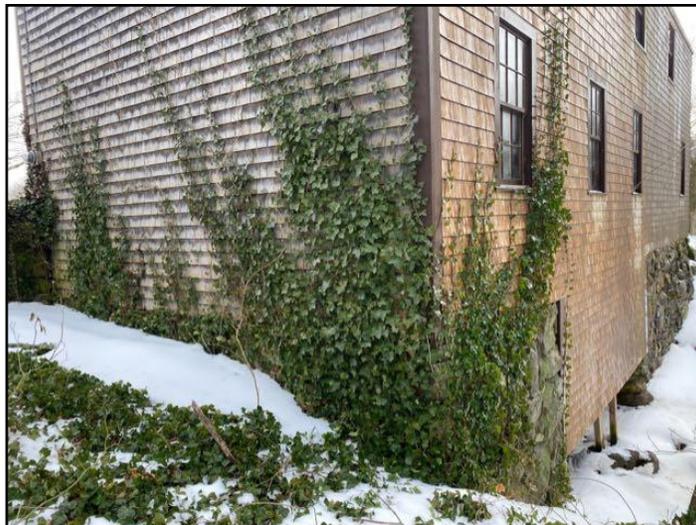
Vines are growing on several elevations of the mill structure. This vegetation should be removed as it can damage the siding, trap moisture against the siding and promote the transfer of insects into the building. Consult with a qualified landscaping company.

*Vines on mill structure*

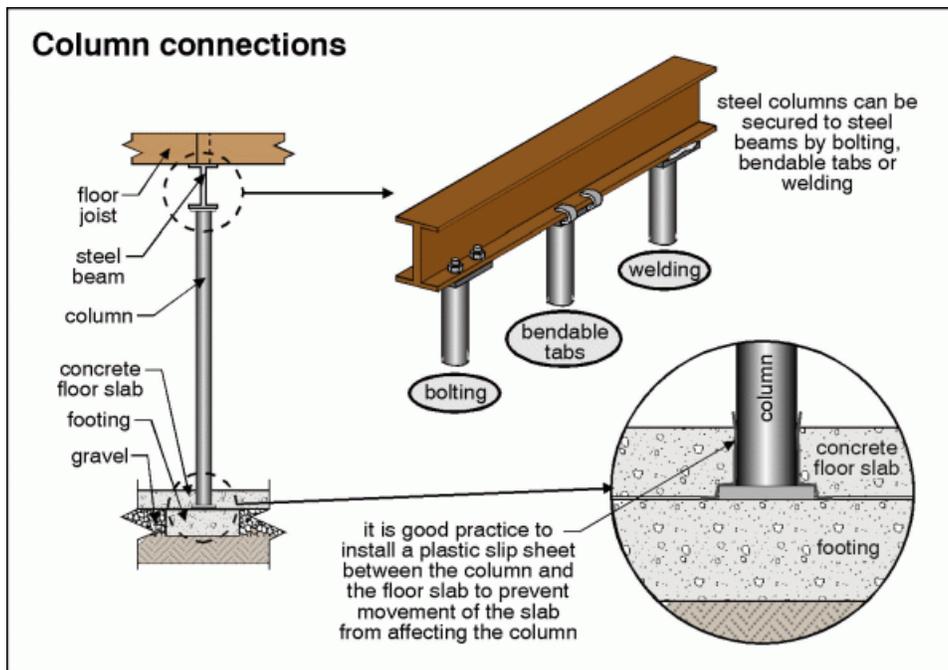
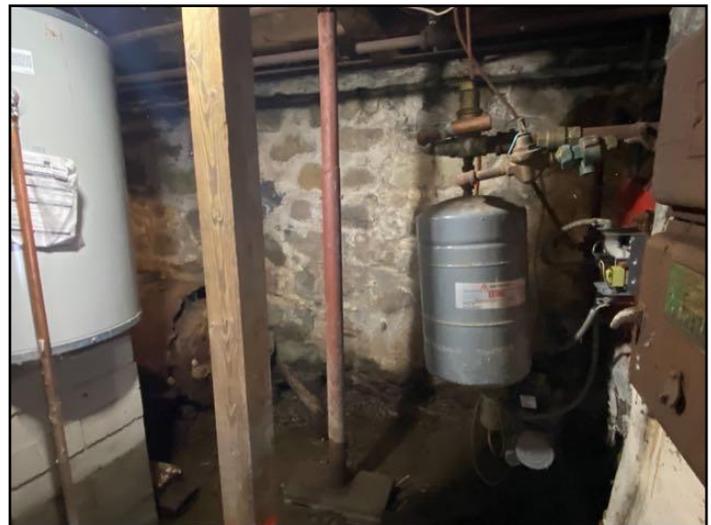
There are numerous screw columns located in the basement. Given the wet environment, a fair amount of surface rusting was present on these features. By definition, these types of columns are strictly meant as temporary supports. All too often, they are left as a means of permanent installation. Recommend that you discuss these features with a qualified contractor and consider upgrading them to true Lally columns.

Improvements recommended

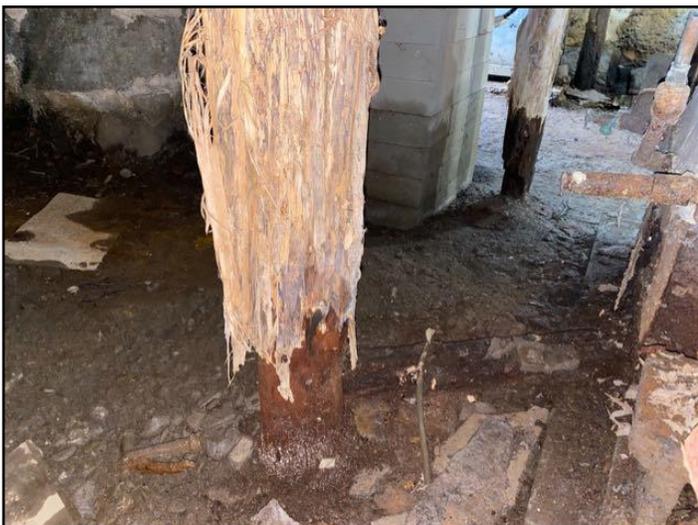
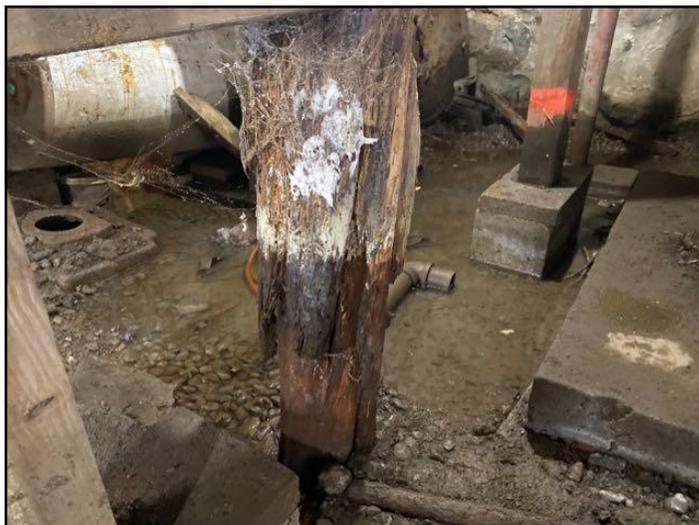
There are several older, cedar support posts in the basement of the residence. These feature have sustained significant damage from exposure to water. They should be the subject of through evaluation by a qualified contractor. Improvements to internal supports will be needed.

Heavy decay to cedar posts

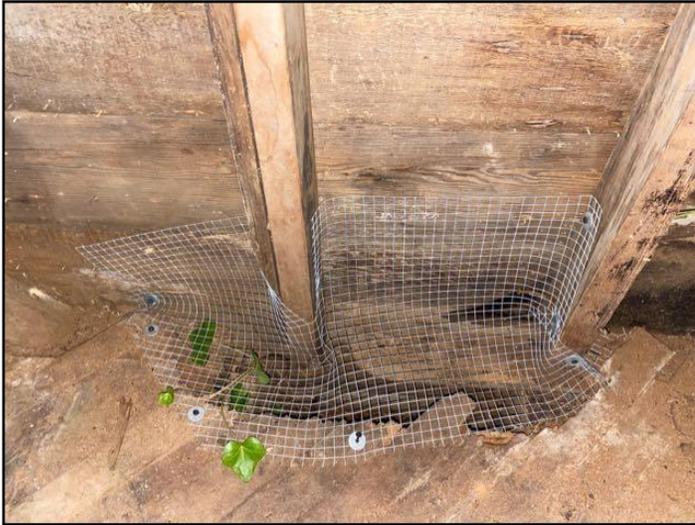
Water has been gaining access to the rear interior of the mill for some time. Relatively significant amounts of water damage and decay were noted along this elevation from the roof line down to the first floor. Moisture readings were taken from a variety of areas along the interior of this elevation and all were high, increasing the lower you went on the elevation, (which is not surprising). While this report is not diagnostic in nature, it appears the roof flashing along the length of this elevation failed years ago and has ever since been allowing water to run inside the wall along framing and sheathing. Compounding this condition, prevailing winds along this rear elevation work to blow any roof drainage back against the siding. Further evaluation is promptly need to arrest any further water infiltration. While it is currently unlikely that framing members have suffered terminal amounts of damage, a general contractor or qualified specialist should be brought in to properly document and evaluate the framing. If left unaddressed, damage will most likely become more structurally compromising.

Heavy damage to flooring

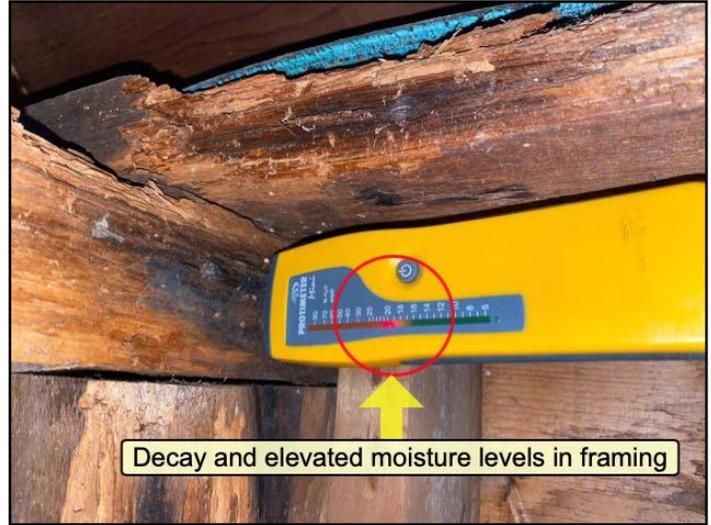
Second floor, rear plate and beam

Decay and elevated moisture levels in framing

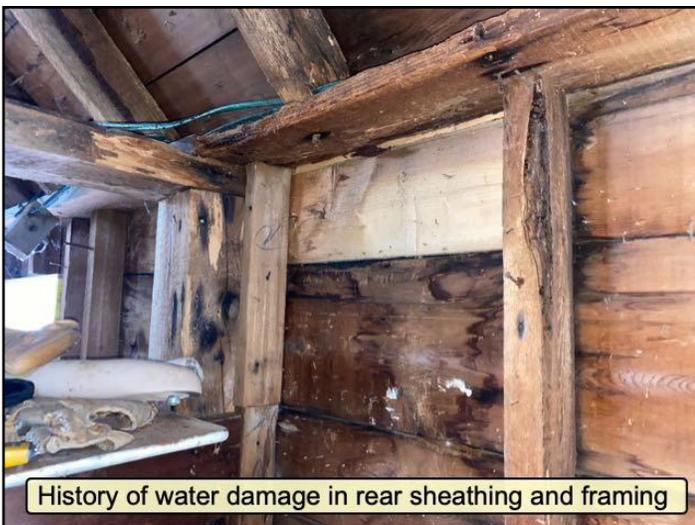
Second floor, rear wall sheathing

History of water damage in rear sheathing and framing

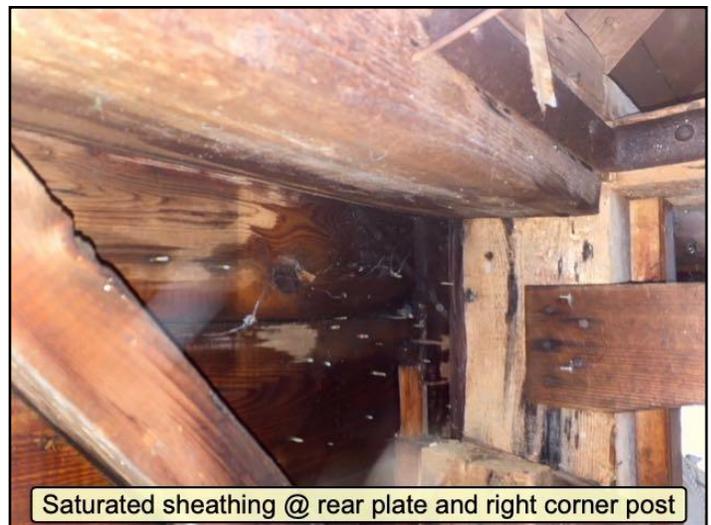
Rear, right plate and corner post

Saturated sheathing @ rear plate and right corner post

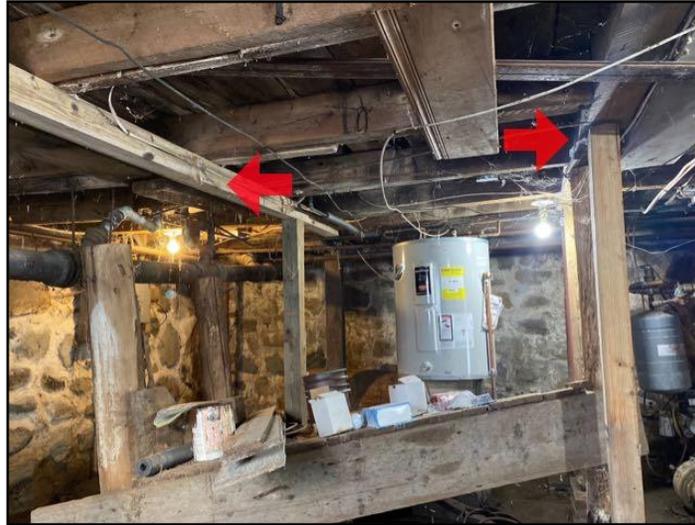
Additional post and beam supports have been installed, running front-to-back, in the basement of the residence structure. These two features are not properly secured in place. At least one post is loose to the touch and none are properly secured where they come in contact with the beam they support. This installation should be further evaluated by a qualified contractor.

*Improvements recommended*

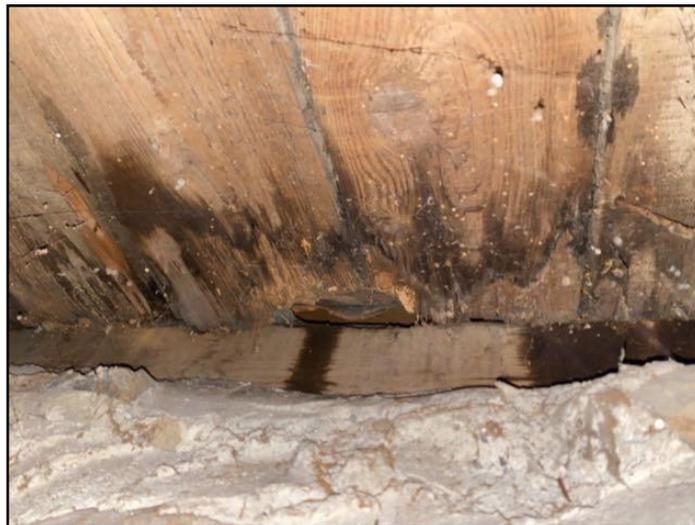
Damage and decay were noted to subfloor at the front of the basement, beneath the front entry vestibule of the residence structure. The scope of this water damage could not be determined and \*may\* include the sill in and around this area. Further evaluation by a qualified contractor will be needed.

*Water damage to sub flooring in residence*

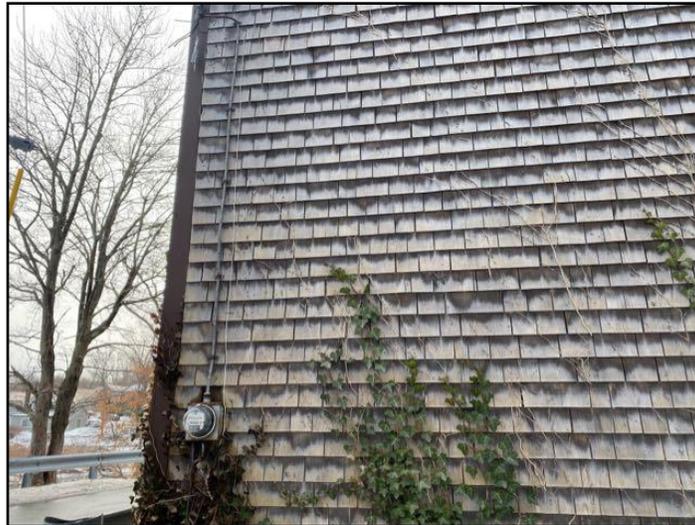
*Service removed from mill structure*

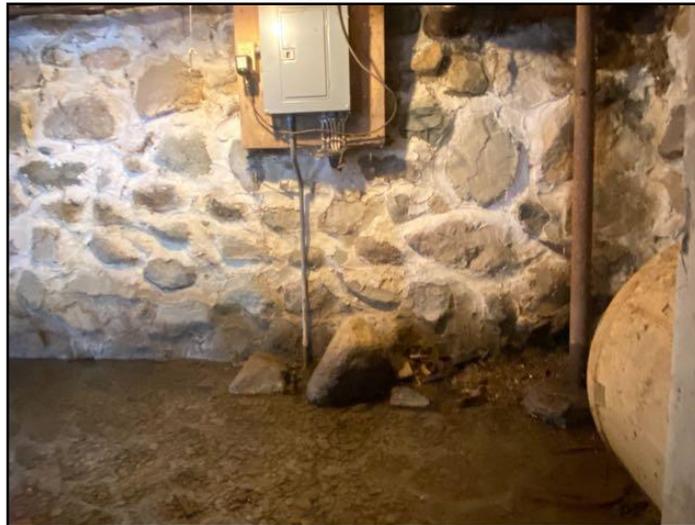
**Inspection limited/prevented by:** • The distribution panel in the basement of the residence was not accessible during this inspection. Nearly half of the basement, from the rear foundation wall to around the middle section, had 3 or 4 inches of standing water. This panel was directly over that standing water. It was not safe to interact with the panel given these condition. It is recommended that you have the panel properly evaluated moving forward.

*Panel above standing water in basement*
